**U.S. Environmental Protection Agency  
Region IX**

**Ten Mile River  
Total Maximum Daily Load  
for Sediment**

**PUBLIC REVIEW DRAFT**

**November 9, 2000**

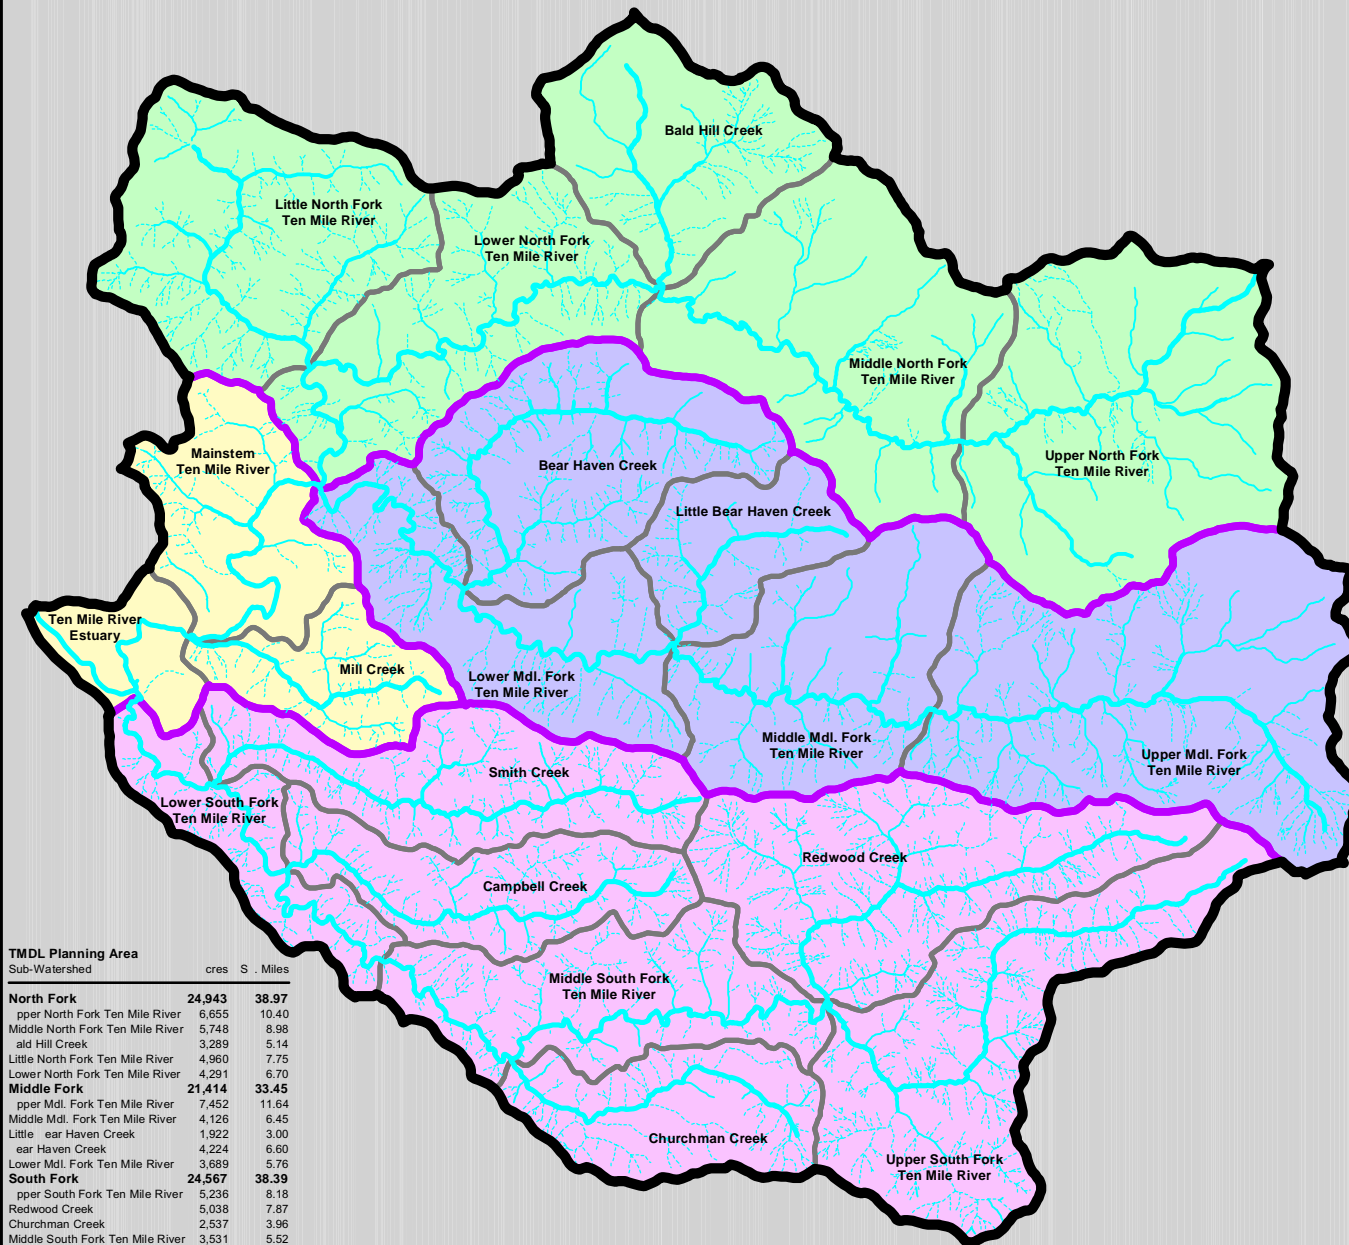
**FIGURE 1**  
**TEN MILE RIVER WATERSHED**  
**TMDL Planning Areas**  
**and Sub-Watersheds**

- Watershed Boundary**
- Planning Watersheds**
- North Fork
  - Middle Fork
  - South Fork
  - Mainstem
- Streams**
- Perennial
  - Intermittent
  - Ephemeral
- Sub-Watersheds**
- Former USGS Gauge**

The problem statement includes an assessment of existing conditions that led to the 303(d) listing of the water body. The watershed is divided into four Planning Watersheds (PW): North Fork, Middle (Clark) Fork, South Fork, and Mainstem Ten Mile River (see Figure 1).

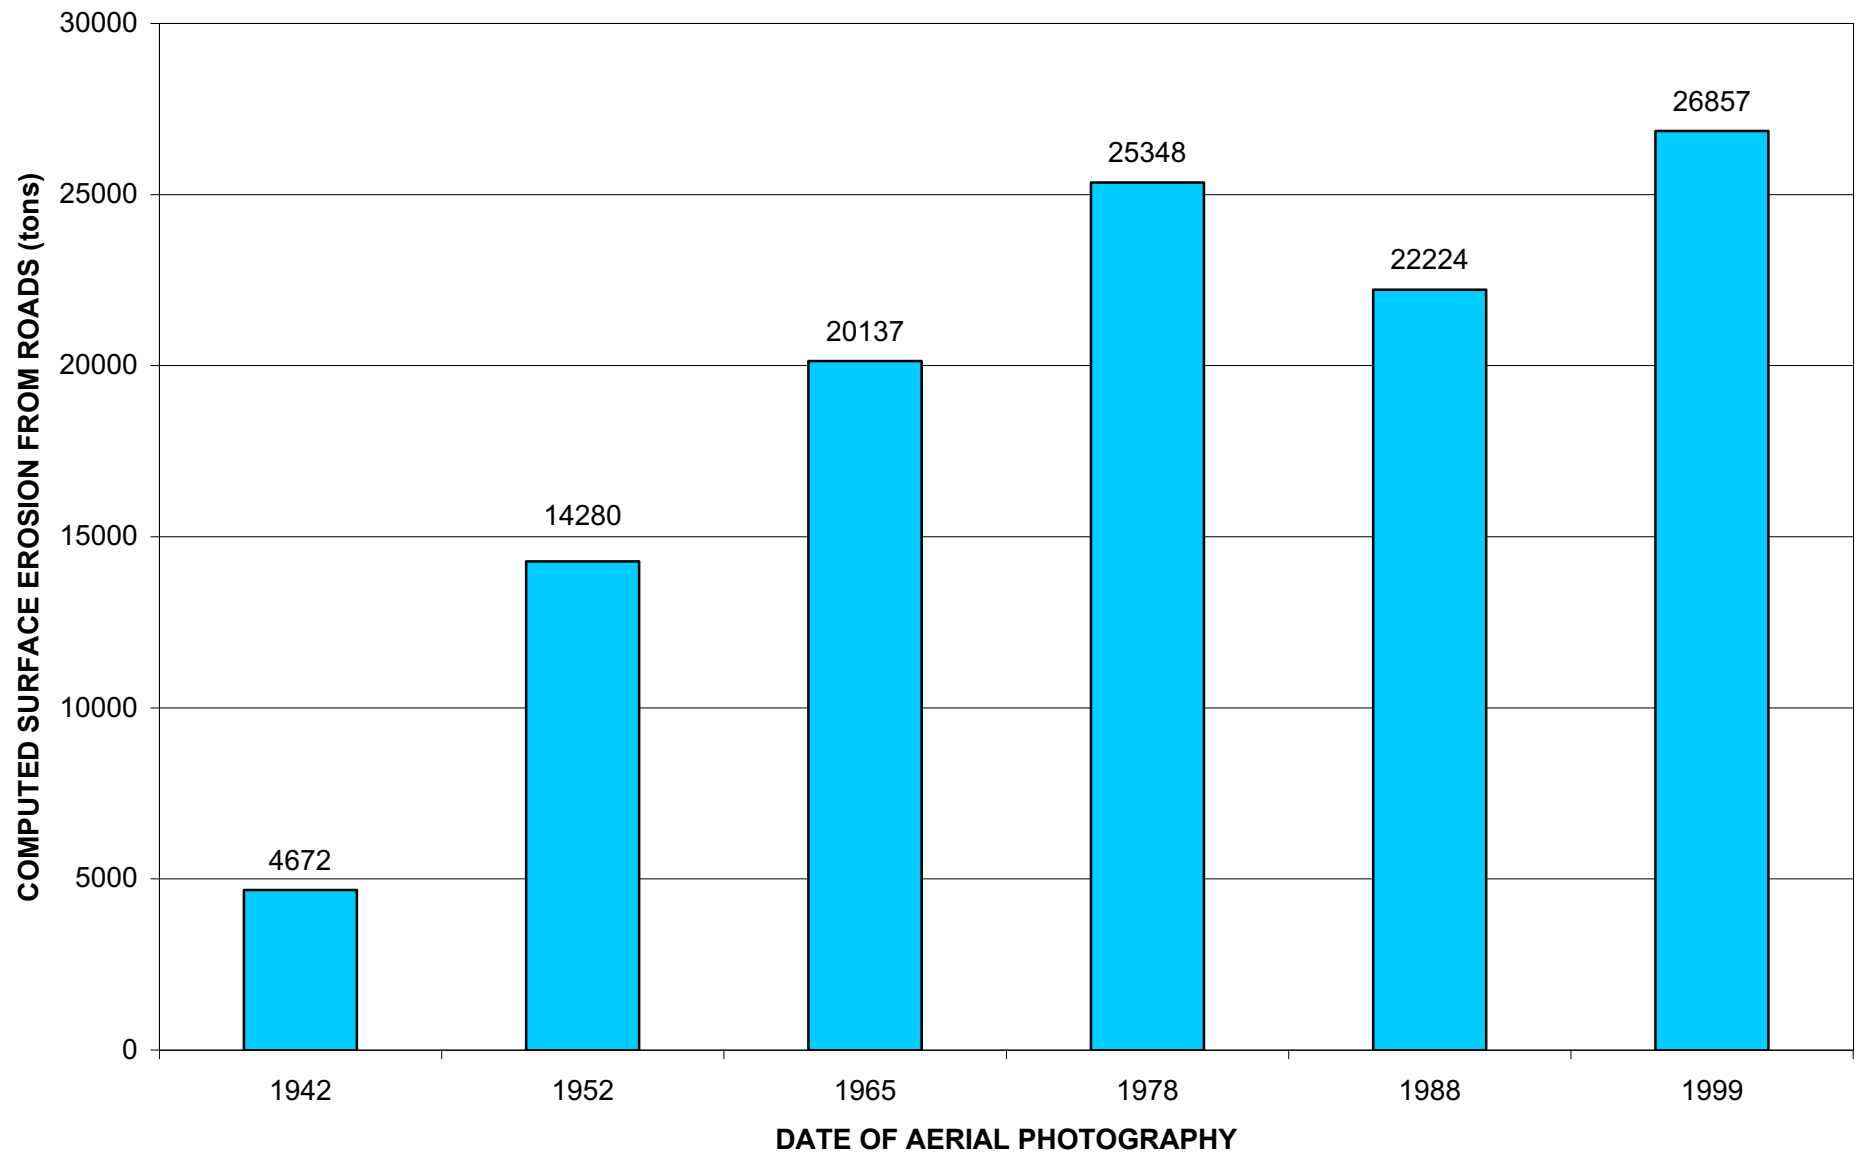
**FIGURE 3**  
**TEN MILE RIVER SEDIMENT SOURCE ANALYSIS**  
Computed Road Surface Erosion by Study period

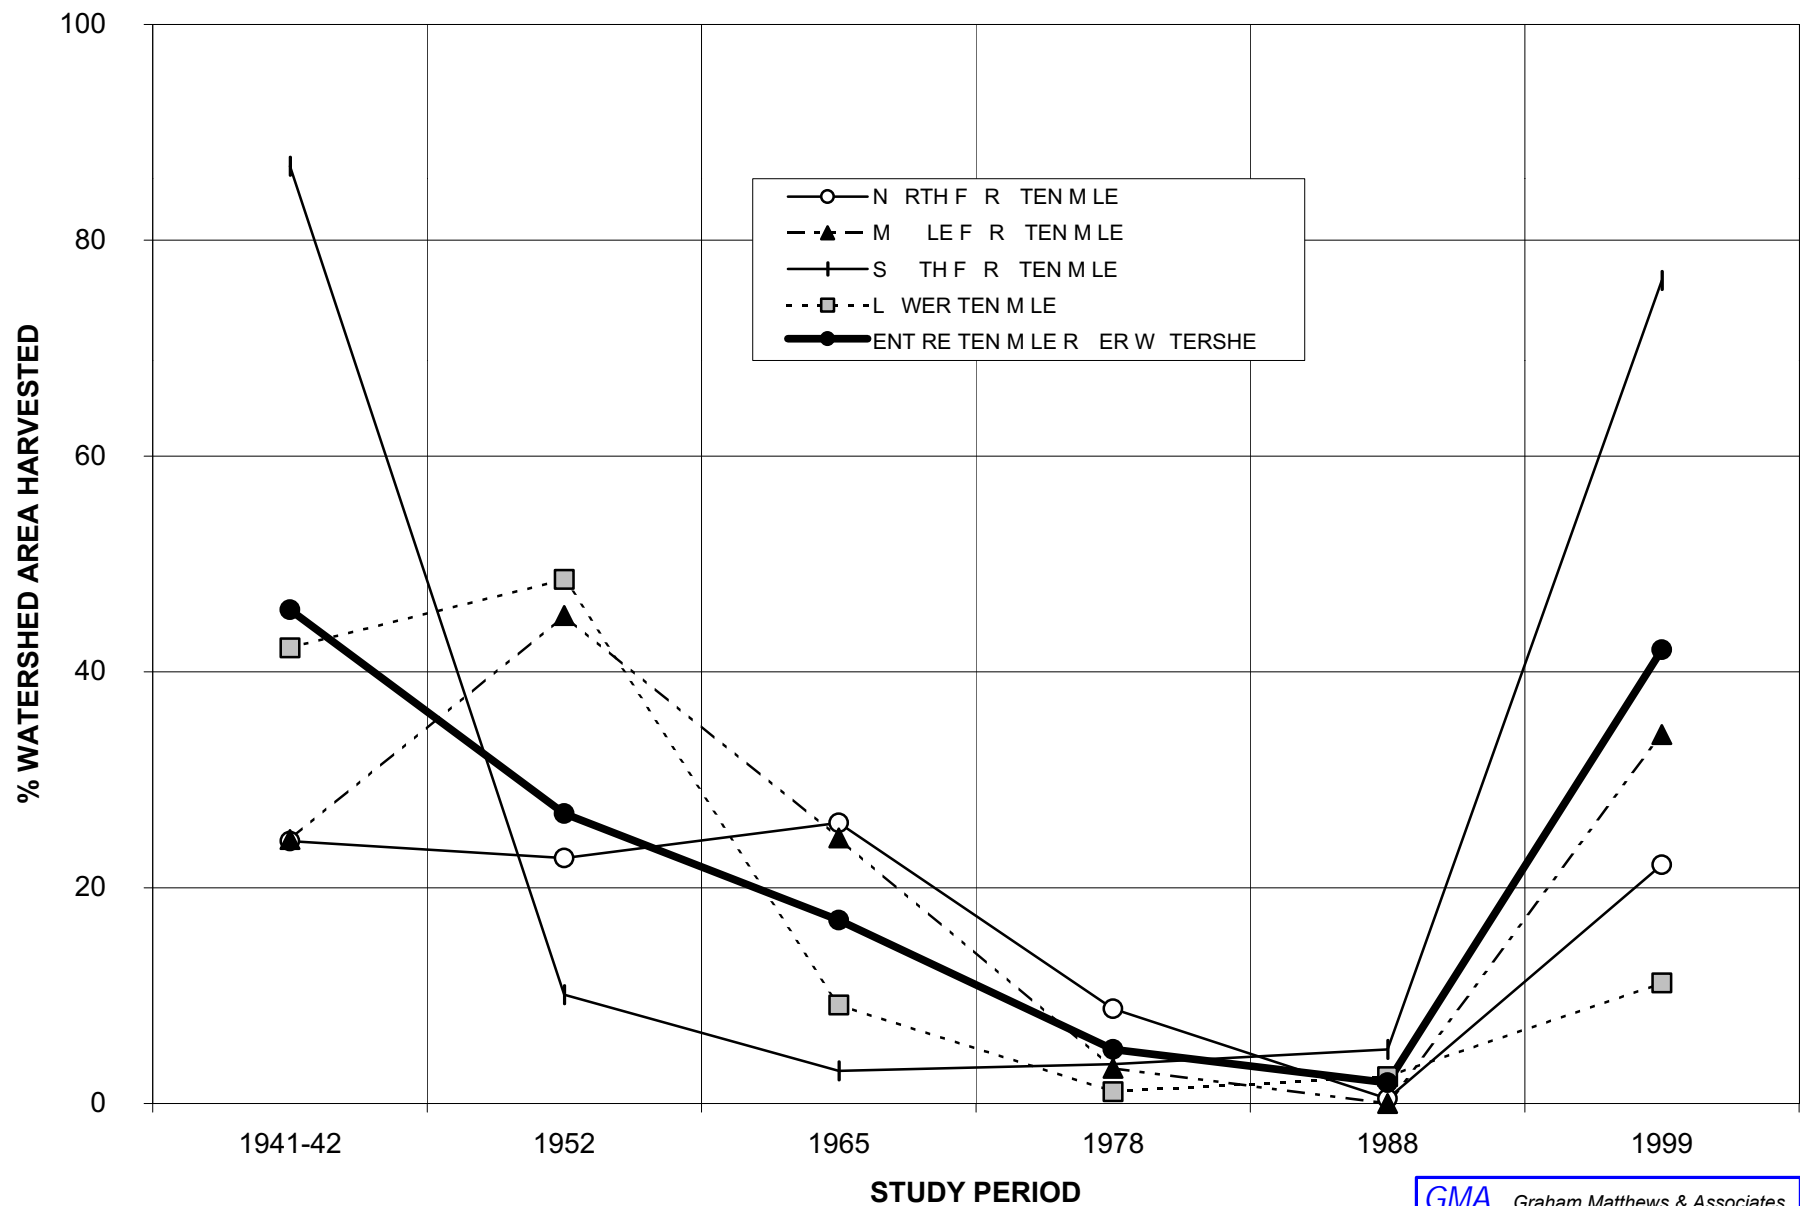
**FIGURE 4**  
**TEN MILE RIVER SEDIMENT SOURCE ANALYSIS**  
 Harvest History of Lanning Watersheds by Study Period

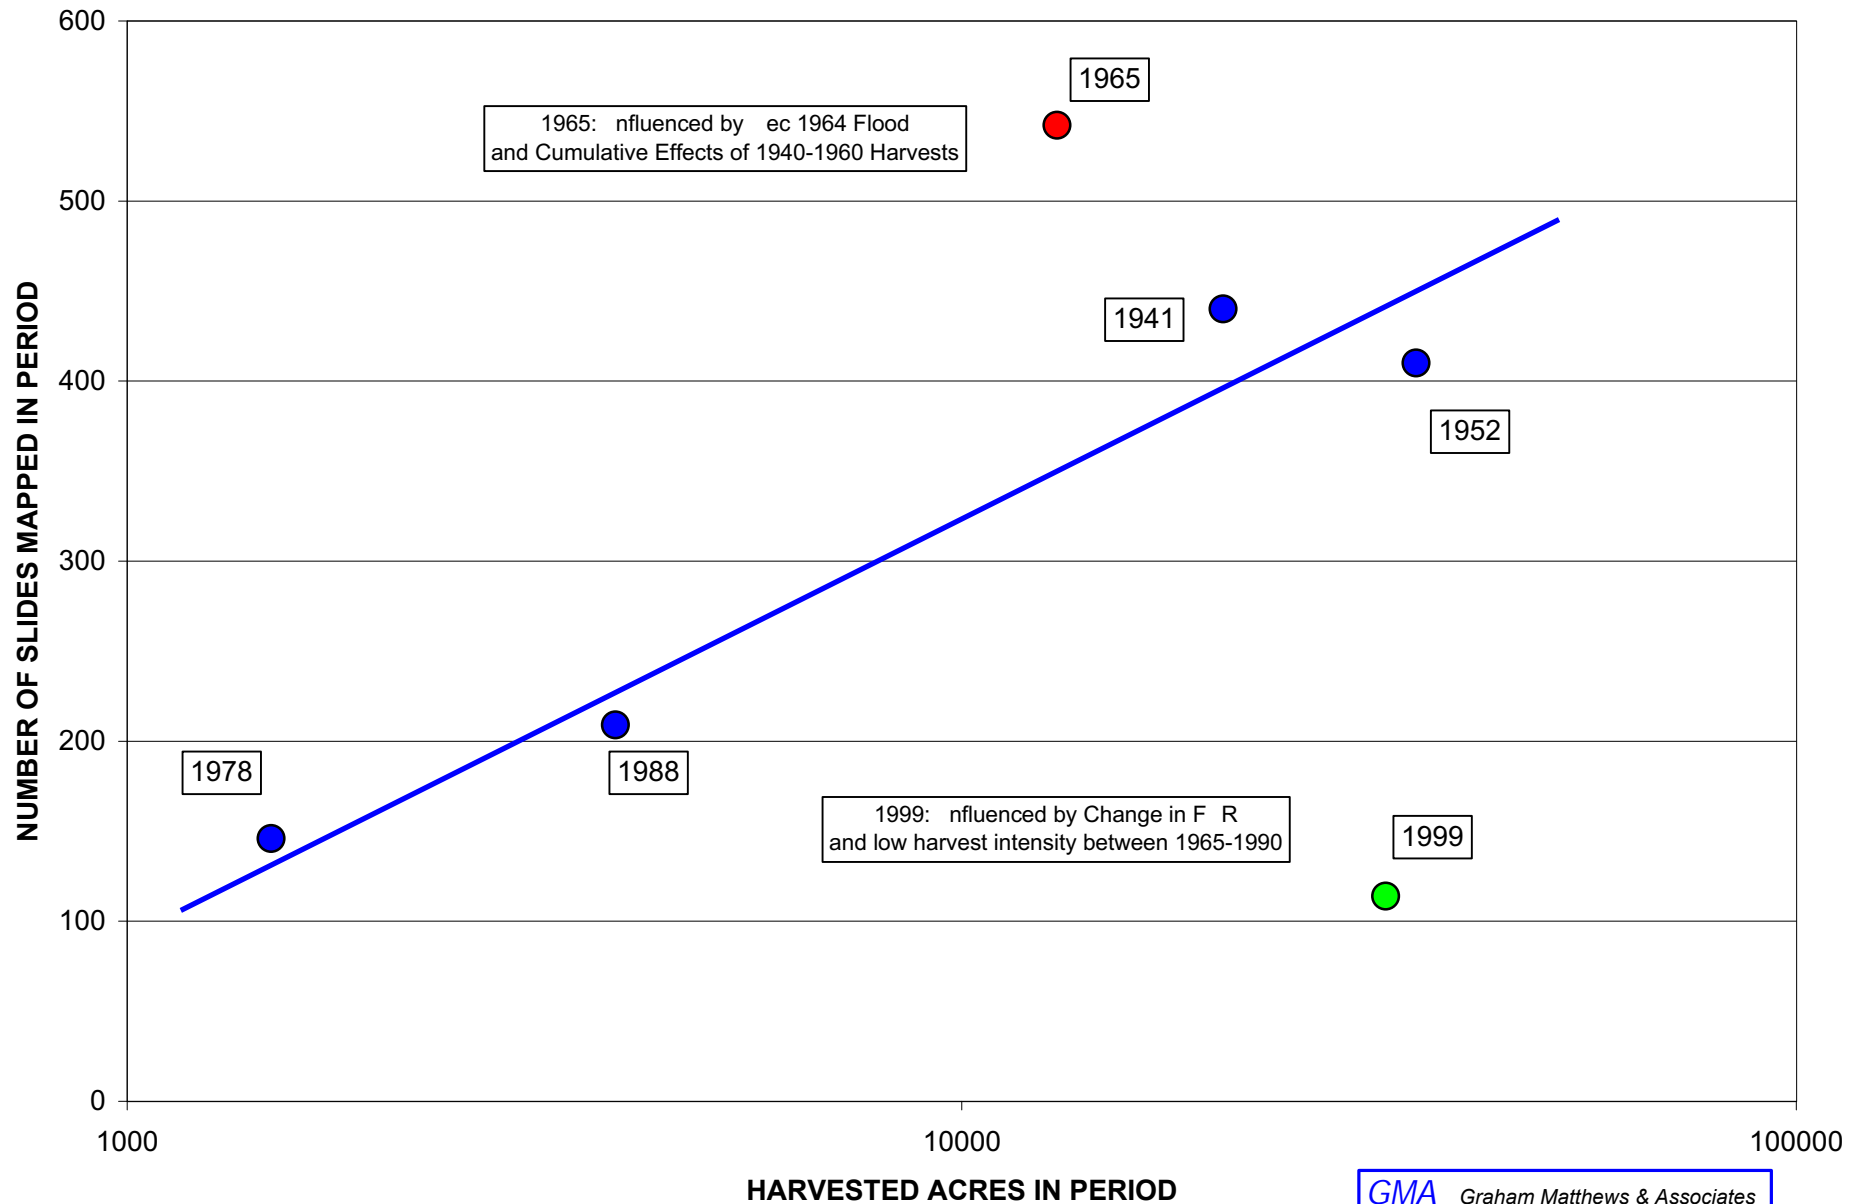
**FIGURE 5**  
**TEN MILE RIVER SEDIMENT SOURCE ANALYSIS**  
Harvest acreage vs. Number of Slides for analysis periods

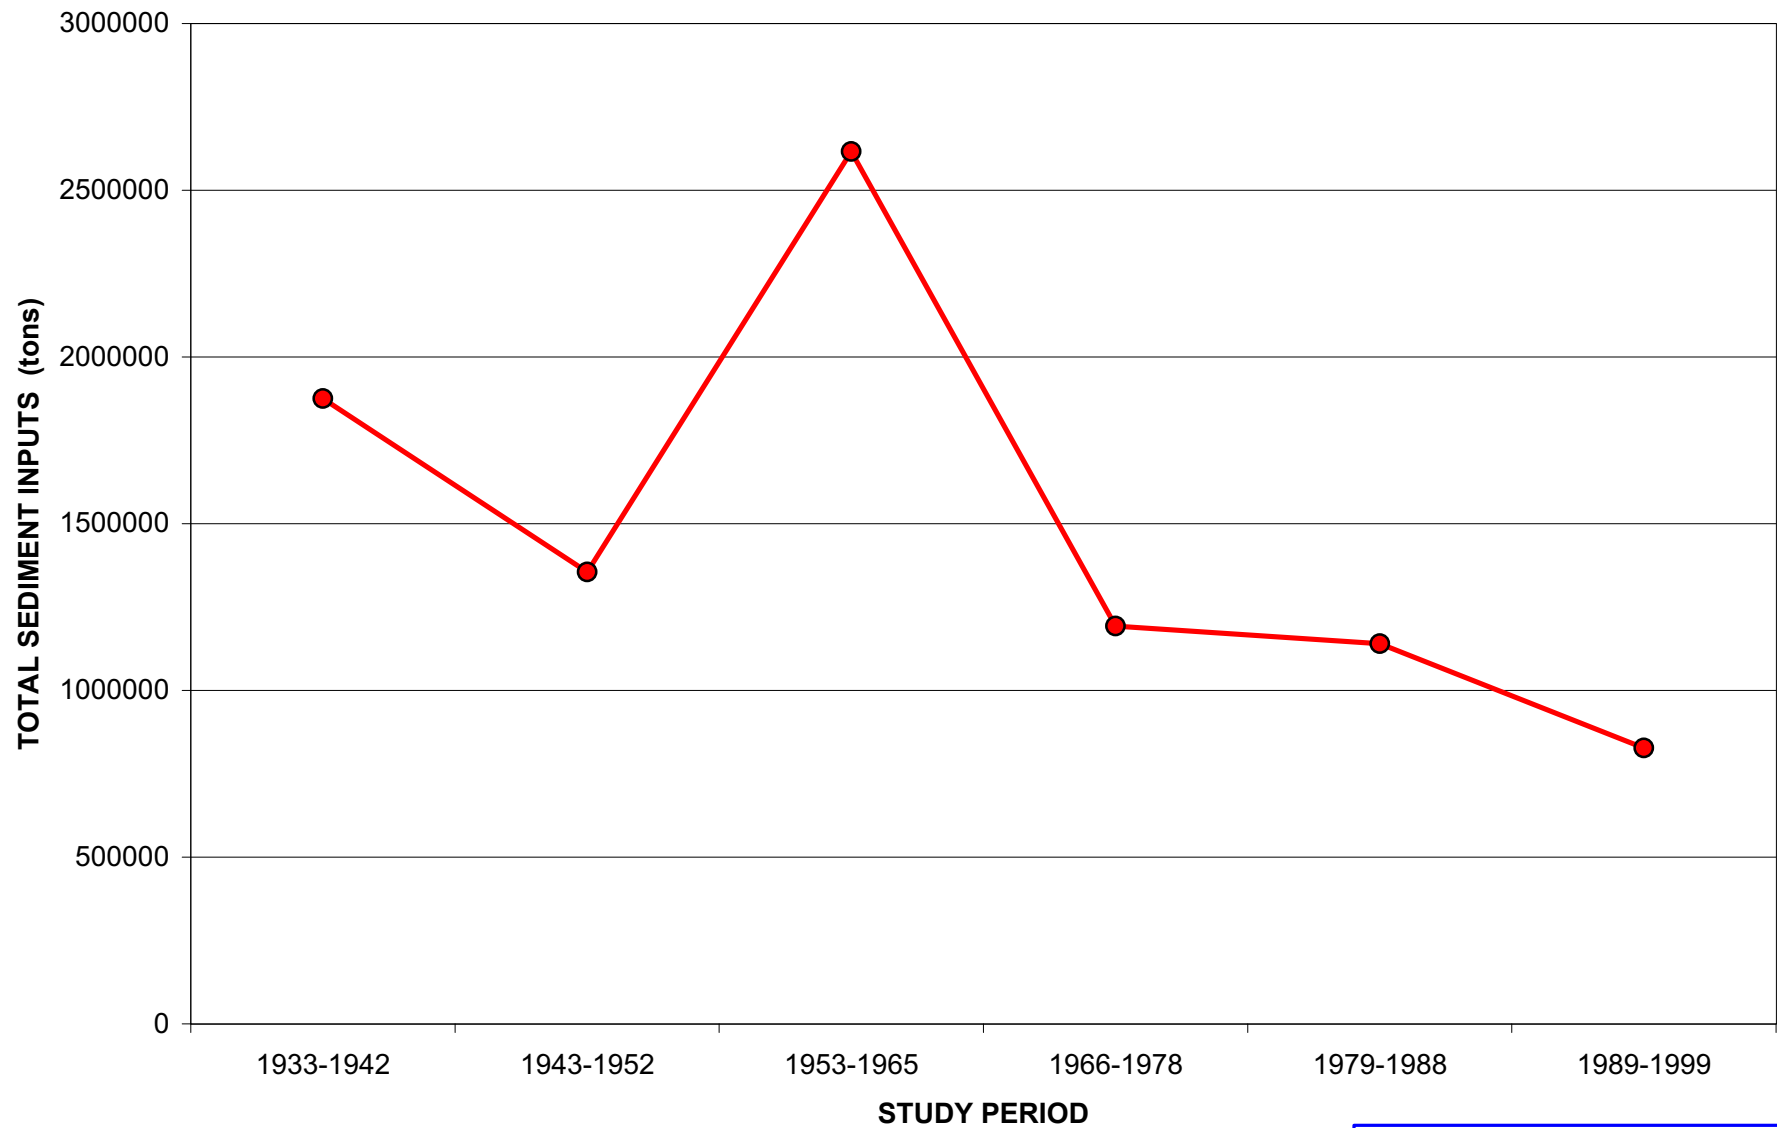
**FIGURE 6**  
**TEN MILE RIVER SEDIMENT SOURCE ANALYSIS**  
Estimated Total Sediment Inputs by Study Period
